NIST Response to the World Trade Center Disaster

Federal Building and Fire Safety Investigation of the World Trade Center Disaster

March 15, 2005

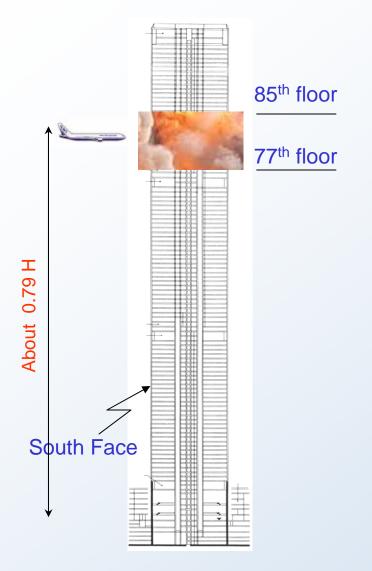
WTC 2: Hit at 9:02:59 AM Collapsed after 56 minutes

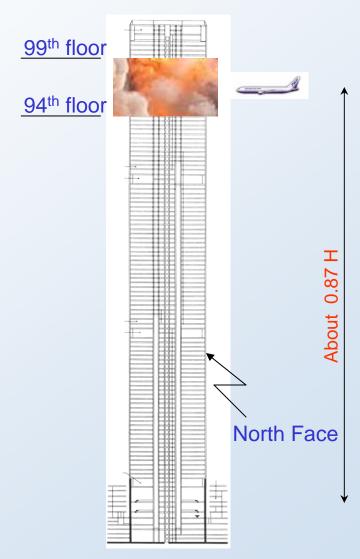
WTC 1: Hit at 8:46:30 AM Collapsed after 102 minutes

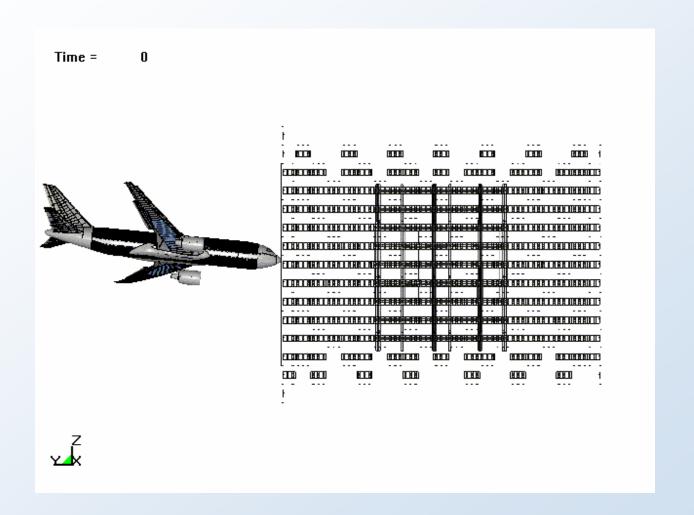
WTC 1 Severe Case

WTC 1 Damage for Severe Case: Composite Summary for Floors 93 to 98

Severe Floor Damage

Fireproofing (SFRM) and partitions

Floor system structural damage

Floor system removed

Column Damage

Severed

Heavy Damage

Moderate Damage (

Light Damage

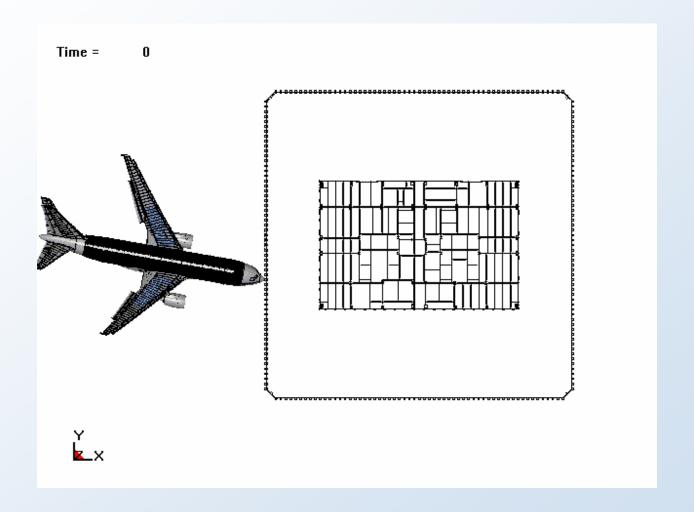
WTC 2 Severe Case

WTC 2 Damage for Severe Case: Composite Summary for Floors 78 to 83

Severe Floor Damage

Fireproofing and partitions

Floor system structural damage

Floor system removed

Column Damage

Severed

Heavy Damage

Moderate Damage (

Light Damage

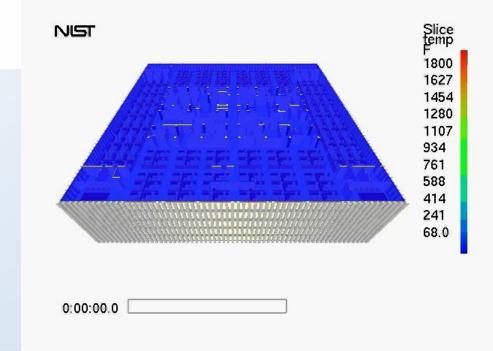
Reconstruction of the WTC Fires

- Fires played a major role in further reducing the structural capacity of the buildings, initiating collapse. While aircraft impact damage did not, by itself, initiate building collapse, it contributed greatly to the subsequent fires and the thermal response of the structures by:

- Increasing air supply into the damaged buildings, allowing fires to spread rapidly on multiple floors;
 - Damaging and dislodging fireproofing from structural components; and

- Damaging ceilings that enabled "unabated" heat transport over the floor-to-ceiling partition walls and to structural components.
- The jet fuel, which ignited the fires, was mostly consumed within the first few minutes after impact. The fires that burned for almost the entire time that the buildings remained standing were due mainly to burning building contents and, to a lesser extent, aircraft contents, not jet fuel.

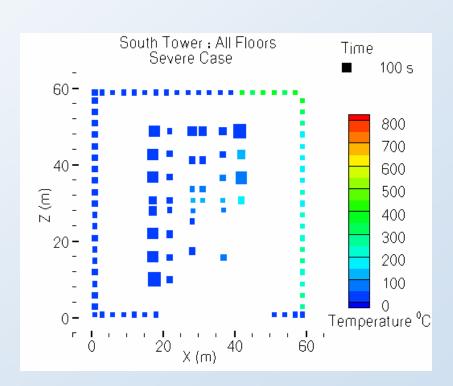
WTC 2

Results of Thermal Analysis (Severe Case)

Shows maximum temperature reached by each column.

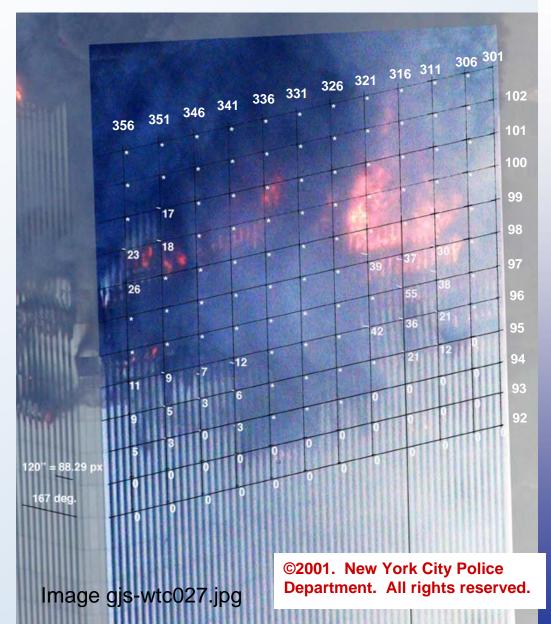
South Face of WTC1

- Time: 10:22 AM
- Measurements of inward bowing (inches)
- Maximum = 55 inches
 (uncertainty ~ +/- 6 inches)

- Floor locations approximate
- Blue tinted region digitally enhanced

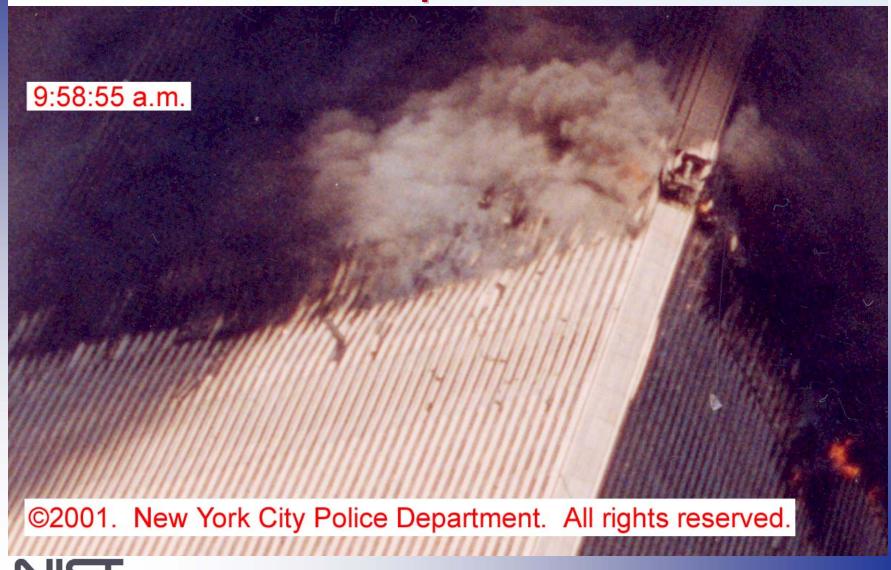
Inward Bowing of Perimeter Columns Some Minutes Prior to Collapse: WTC 2 East Face

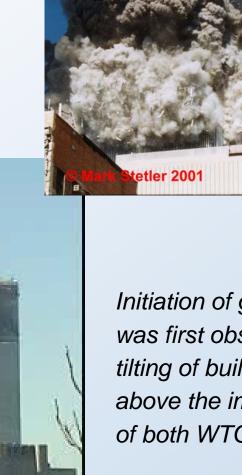
Tilting of Building Sections

WTC 1 tilted to the south; WTC 2 tilted to the east and south and twisted in a counterclockwise motion

Initiation of global collapse was first observed by the tilting of building sections above the impact regions of both WTC towers.

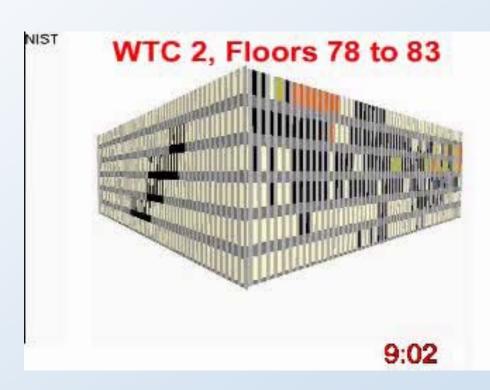
Collection and Analysis of Photographic and Video Images

- Visual database contains:
 - Well in excess of 7,000 photographs taken by more than 185 photographers
 - 150 hours of videotape from major media outlets and more than 20 individuals
- From the analysis of the visual images to date, NIST has identified significant events for WTC 1 and 2 related to aircraft impact, fire development, and building damage
- NIST has developed detailed mappings for the fire, smoke, and the condition of windows at several specific times for each WTC tower; work is nearing completion for WTC 7

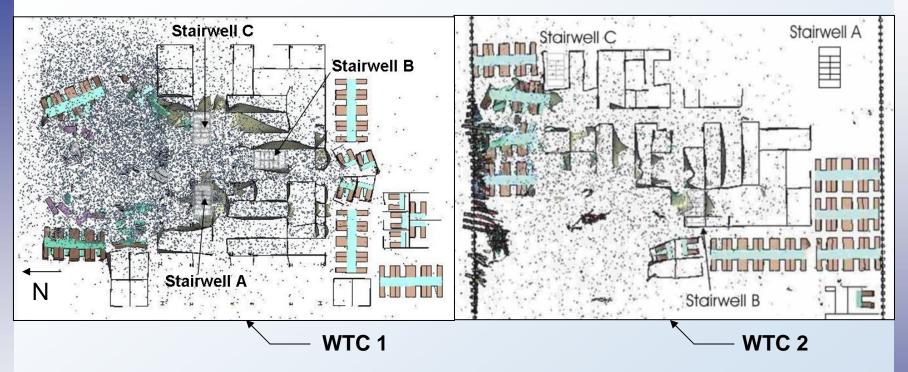
Condition of Stairwells

- The stairwells, with partition wall enclosures that provided a 2 h fire-rating but little structural integrity, were damaged in the region of the aircraft impacted floors.
- One of the stairwells in WTC 2 (Stairwell A on the Northwest side) was passable in the region of aircraft impact for some period of time after WTC 2 was attacked.
- All three stairwells in WTC 1 and the two other stairwells in WTC 2 were rendered impassable in the region of aircraft impact.

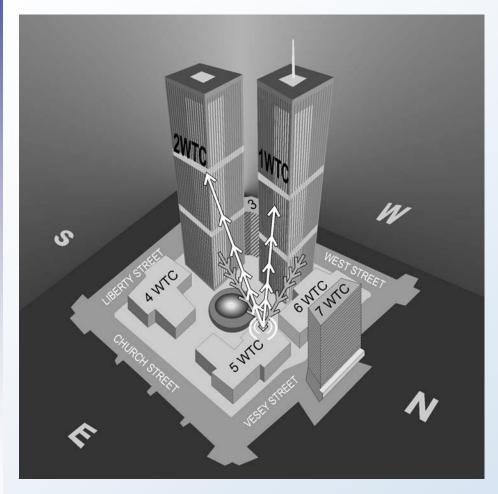
Schematic of WTC Radio Repeater System

- Challenging radio-frequency propagation environment: steel and reinforced concrete buildings.
- Large scale operations.
 - Number of first responders.
 - Communications hierarchy and protocols.
 - Surge in traffic; doubling.
- Interoperability of radio communication technologies among different first responder organizations.
- Identification, location, tracking first responders.

- It is possible that one or both of the following conditions complicated the radio check that took place at the WTC 1 Lobby Command Post:
 - The radio repeater handset earpiece was broken.

- The radio repeater handset volume was not turned up.
- It is unlikely that the repeater's antenna was broken or misdirected by debris since radio signals were received during the radio check from inside WTC 1 and the communications that followed from inside WTC 2. Even if the repeater was functioning, it is possible the quality of communications was inadequate.

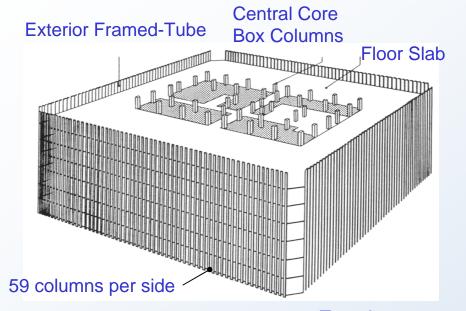
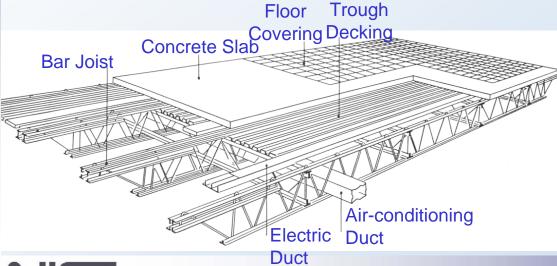
Innovative WTC Tower Structural System

- Innovative structural system when built; incorporated many new and unusual features
- Two features require additional consideration:
 - Composite floor truss system using long span open-web bar joists and spray-applied fireproofing
 - Design for wind loads and control of windinduced vibrations
